13133

VOLKSWAGEN TIGUAN

INSTALLATION STEPS

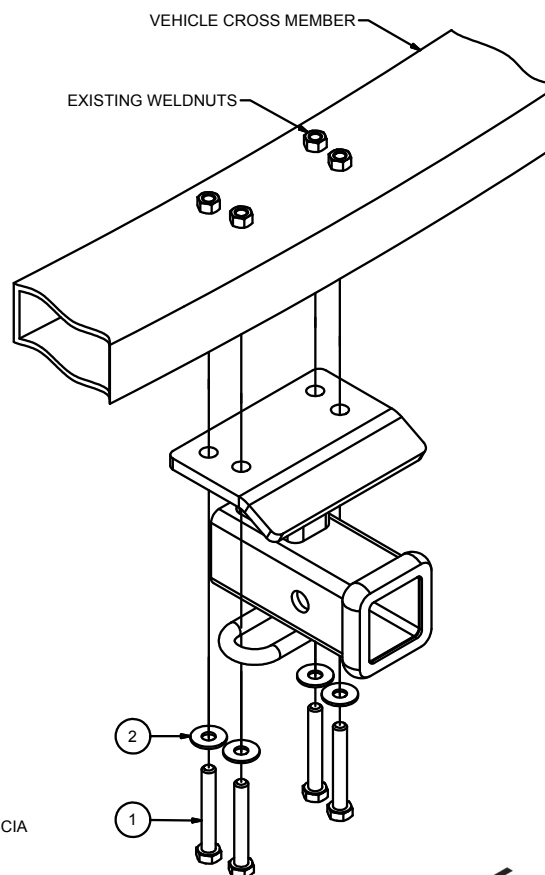
INSTALLED HITCH POSITION

FRONT
↑
REAR

1. Locate existing grooved area on bottom of fascia. Trim fascia as shown in TRIM DIAGRAM. On R-Line models locate contour in bottom of fascia. Trim as shown in R-LINE TRIM DIAGRAM.
2. Raise hitch into position.
3. Attach hitch to vehicle's cross member using the hardware supplied and the vehicle's existing weldnuts.
4. Torque all M10 hardware to 45 ft-lbs.
