GM8427

2011-2013 CHEVROLET/GMC, SILVERADO/ SIERRA,
HD2500-3500, DURAMAX, DOWN PIPE

16 January, 2013

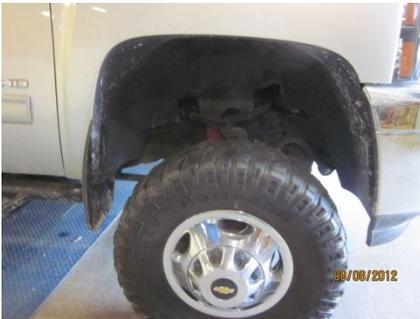
Figure 1

1. Remove the passenger side inner fender. **See Figure 1.**
Note: we also removed the Grille Assembly to prevent damage to it during the removal or installation of the down pipe.
2. Remove the hex bolt securing the down pipe to the exhaust manifold. Remove the sensor located just above the hex bolt. The V-Band clamp connecting the front pipe to the down pipe can also be removed. Save the hex bolt, sensor and V-band clamp for the installation. **See Figure 2.**
3. The front pipe needs to be temporarily removed. Carefully disconnect all sensors and loosen the four flange nuts on the rearward part of the front pipe. The transmission cross-member will need to be temporarily dropped to remove the front pipe. Remember to support the transmission with a block or jack stand while doing the transmission cross member is removal. **See Figure 3.**

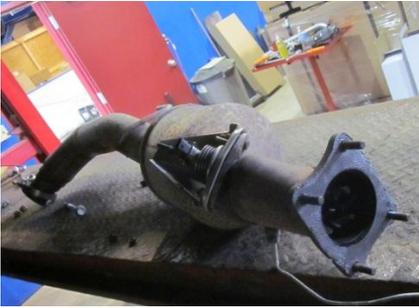
Figure 4

4. The front pipe also has a hanger mounted to the transmission that will also have to be removed. **Figure 4** shows the front pipe assembly removed.
5. The heat shield on top of the turbo will need to be removed. There is also a shield on the back of the down pipe. It runs along the firewall that needs to be removed. The 2 stock sensors on the top of the down pipe need to be carefully removed. Set the sensors aside and save for the installation. The stock V-Band clamp can be removed save for the installation. From the underside of the vehicle carefully slide the stock down pipe out between the frame and transmission.

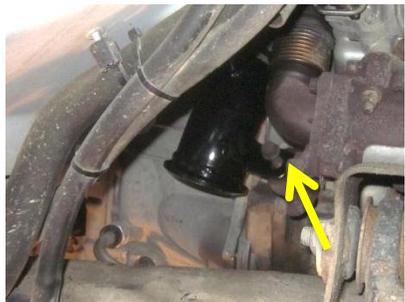
Figure 7

1. Start the install by sliding the **Down Pipe** up from the underside of the vehicle or the passenger side wheel well. Mate the flange up to the turbo and install the V-Band clamp at the turbo. Leave the clamp loose enough for some rotation.
2. Loosely securing the **Down Pipe** to the exhaust manifold with the hex bolt from the stock down pipe. Finish tightening the V-Band at the turbo and then finish tightening the bolt on the exhaust manifold.
3. Install the stock sensors into the **Down Pipe**. One is located along the lower section of the **Down Pipe** (**Refer to Figure 8.**) The other two sensors are located closer to the turbo.
4. The front pipe can then be reinstalled using the stock hardware and V-Band clamp. **Refer to Figures 8 & 9.**

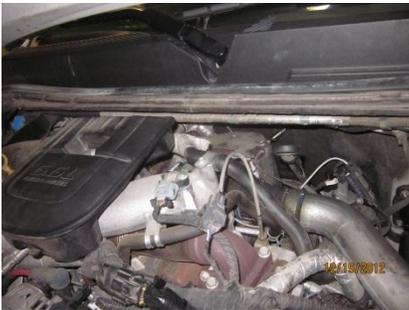
Figure 10

5. Reinstall the exhaust hanger to the transmission cross member. Reinstall the transmission cross member. Reconnect all the sensors to the front pipe.
6. Reinstall the passenger side inner fender.
7. Reinstall the turbo heat shield. **Refer to Figure 10.** Check along the exhaust to make sure all connections are tightened. Check along the whole length of the exhaust system to ensure that there is adequate clearance around the spare tire, fuel and brake lines or any wiring. If any interference is detected relocate or adjust.
